Merrick Log House

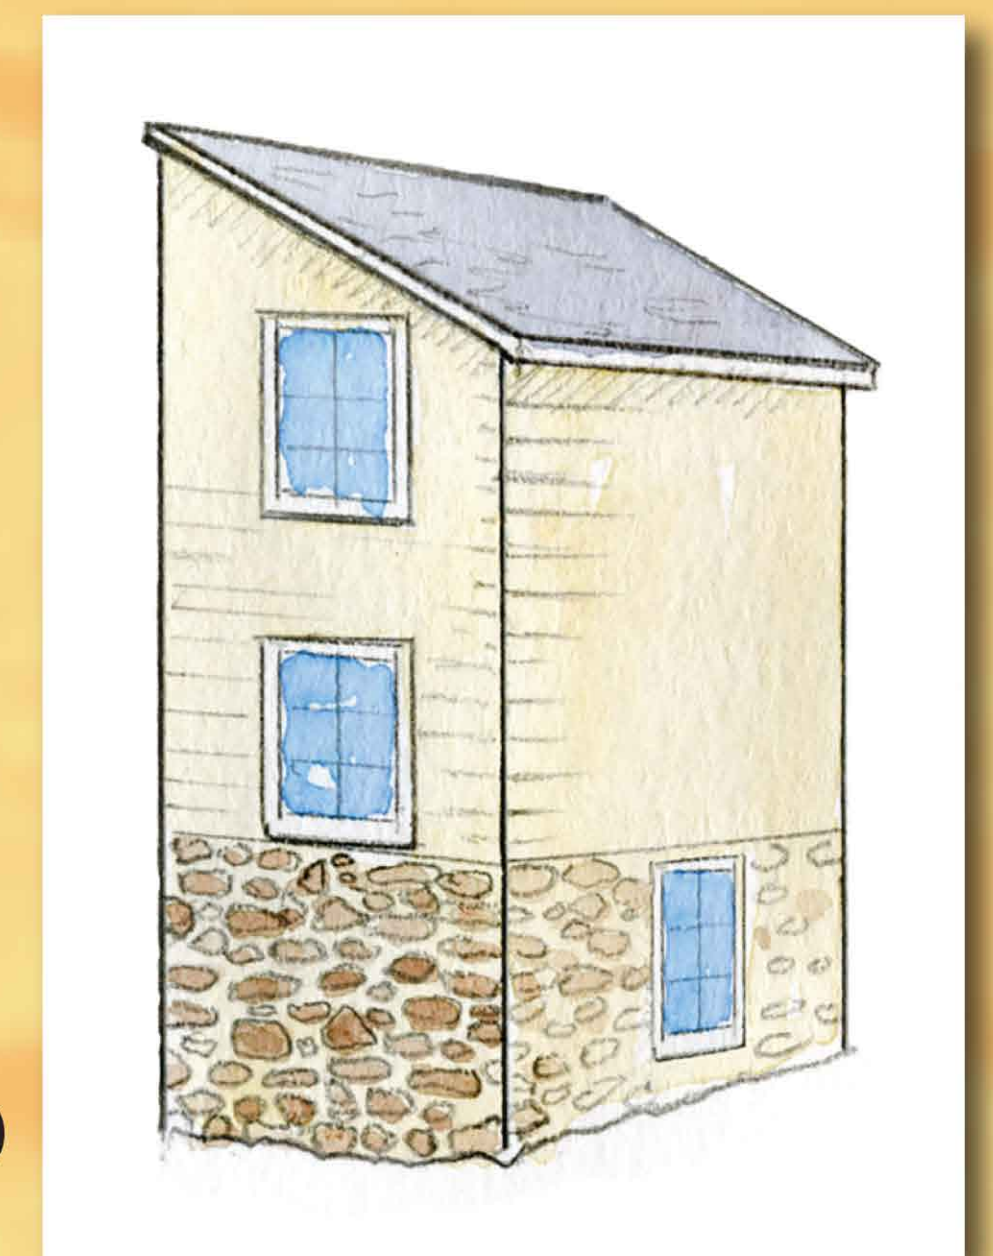
1880

The second addition, added in the 1880s to the north side of the log house, extended west only about $\frac{3}{4}$ the depth of the log house. There was an entrance doorway to this section from the fireplace room. According to tenants in 1949, the first level contained a kitchen and a back door screened porch with another bedroom above on the second floor.

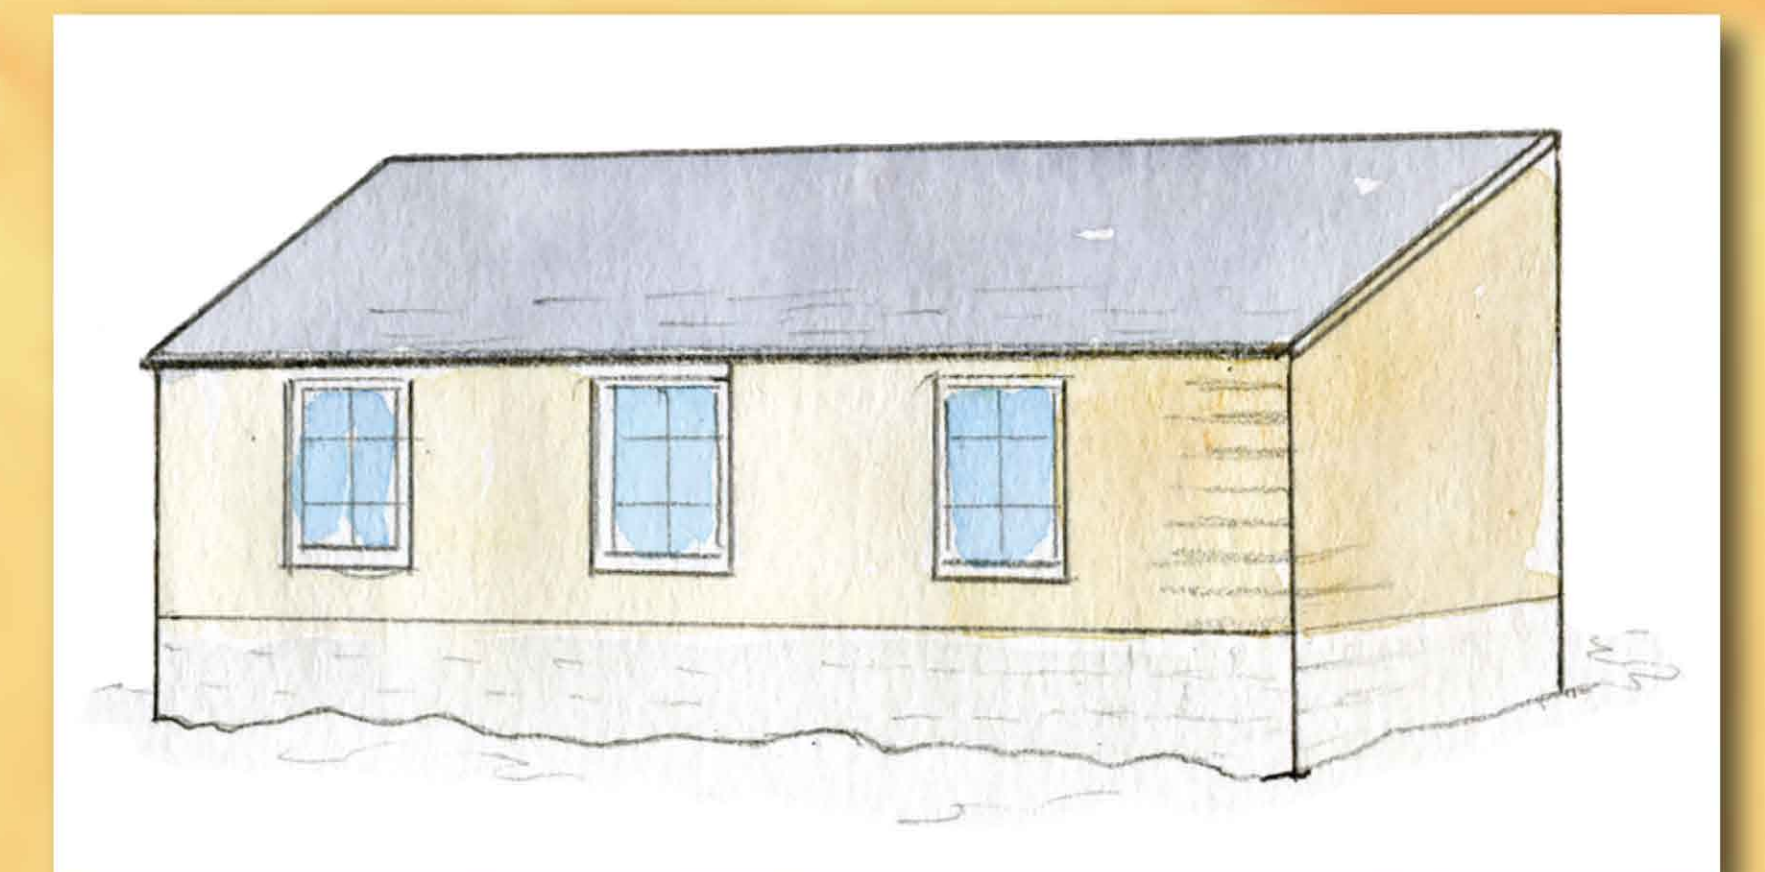
The third and last addition occurred about 1961 just after Robert G. Merrick bought the property from the Jenifer family. Built onto the east side of the log house, this was a large, one story kitchen which contained an oven, a sink with running well water, a stove and lots of wall cabinets. Attached to this kitchen was a small utility room that was removed in 2014 because it was beyond repair.

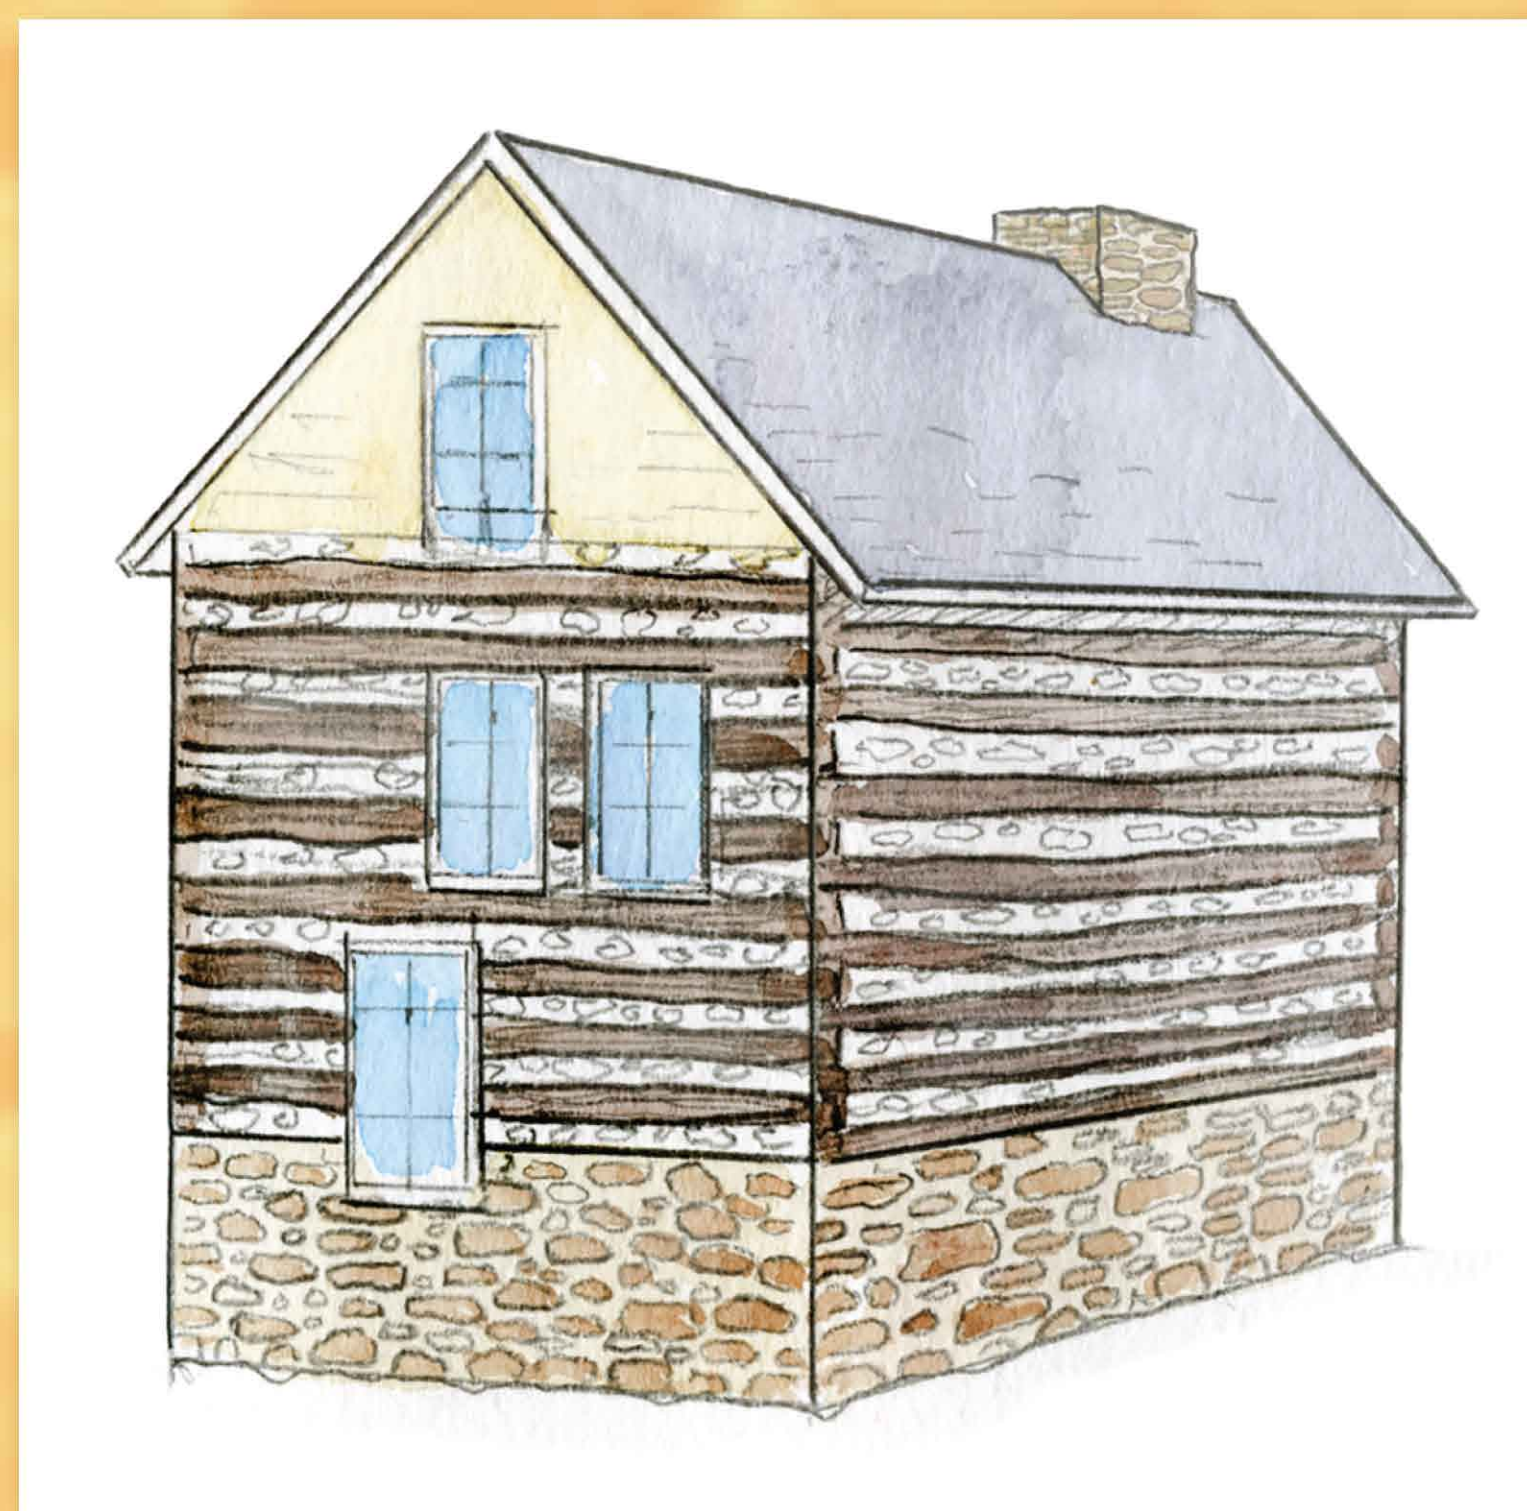
1795 - 1805

The original stone and log house was constructed sometime between 1797 and 1805. (Since then there have been three additions made to the house.) The first level contained a large fireplace room on the first floor with an exposed log beam ceiling. An equally large room on the second floor was most likely used as sleeping quarters. A narrow staircase led from the second floor to a finished attic on the third floor.

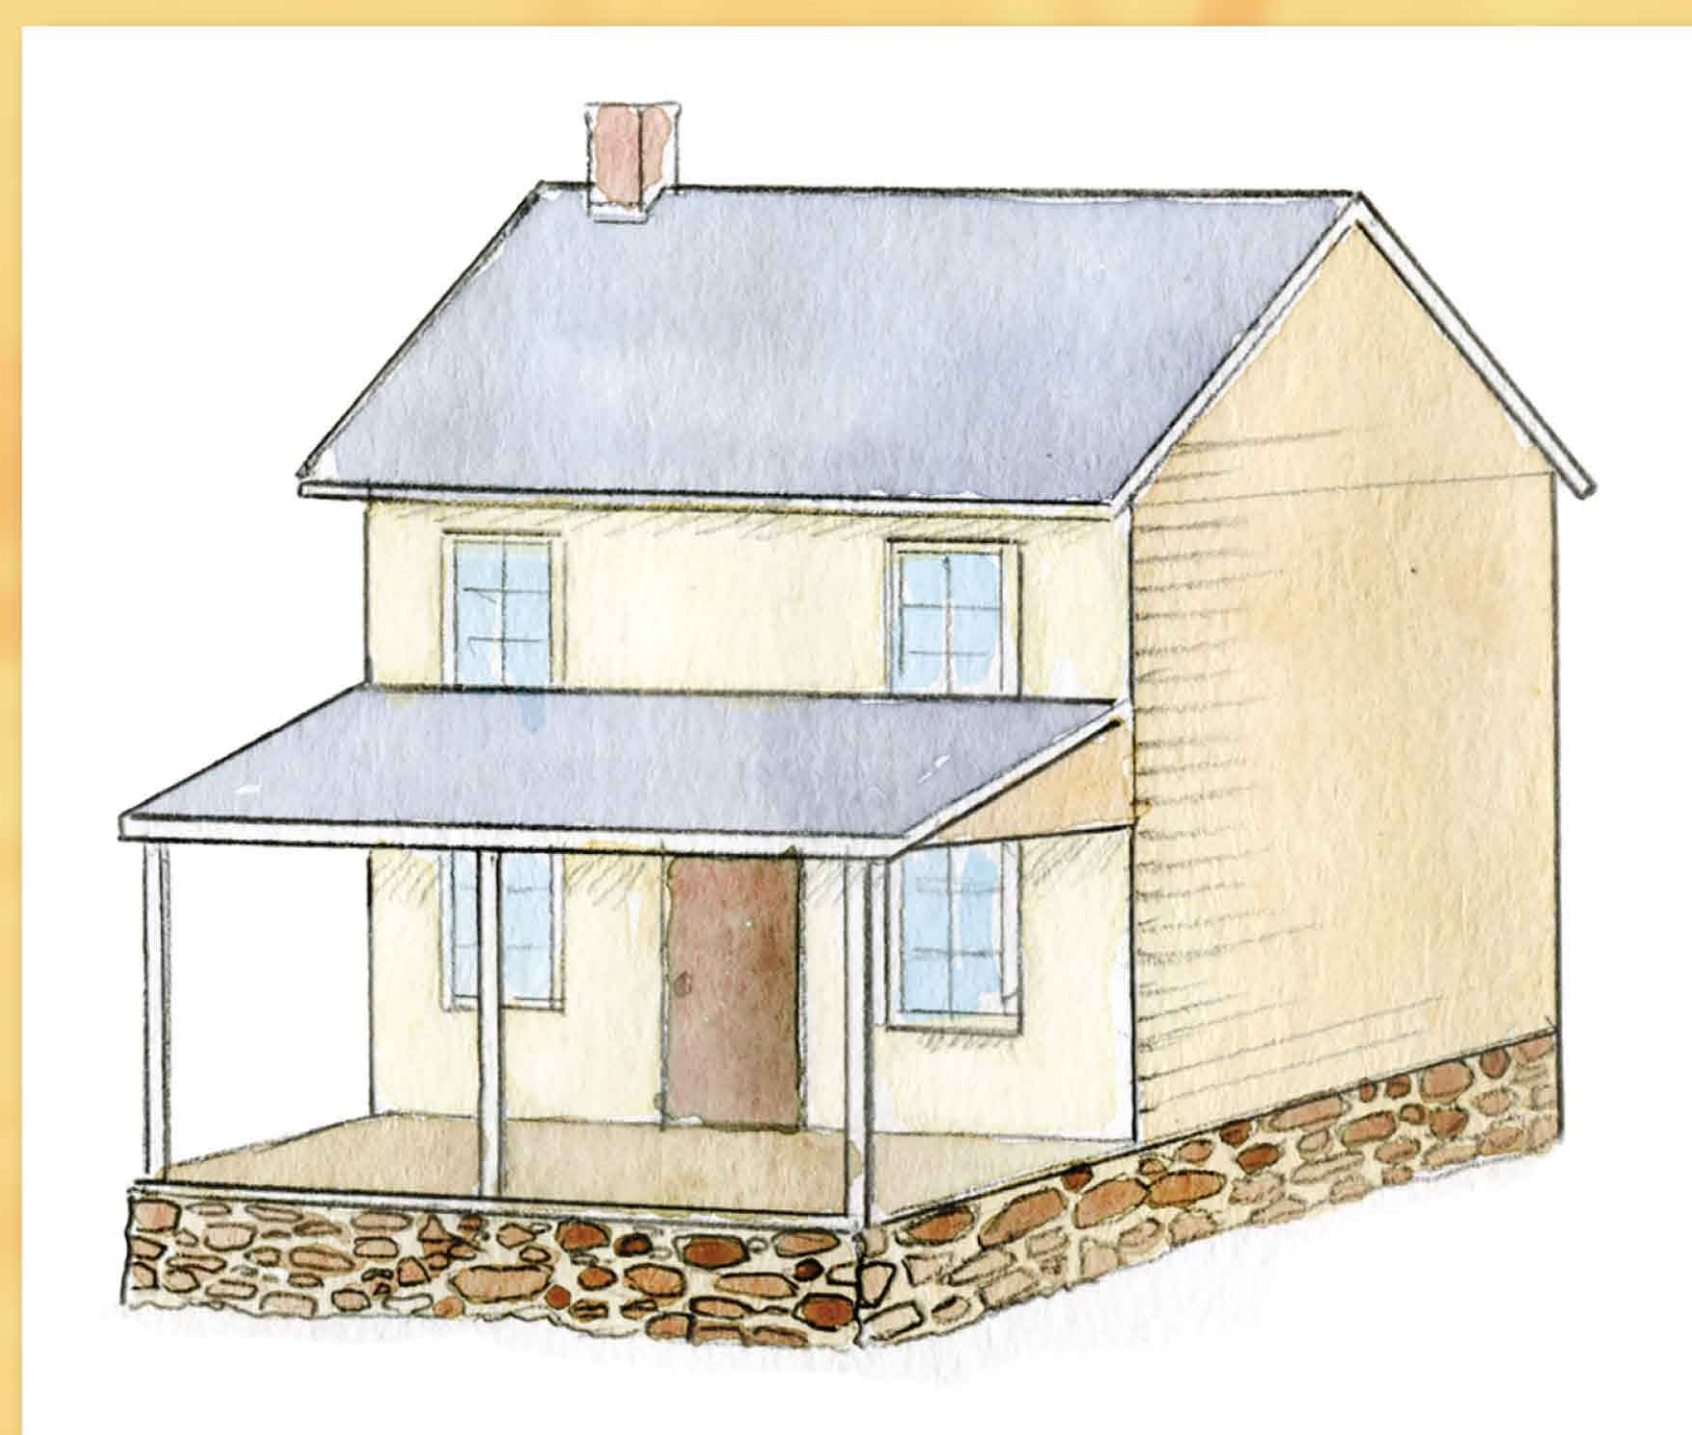
1840 - 1860

The first addition was built onto the south side of the log house sometime between 1840 and 1860. Its first floor contained a living room with an iron furnace or potbelly stove protruding from the south wall chimney and the north wall contained a doorway entrance into the original fireplace room. The west wall supported an on-wall staircase leading to the second floor, with an enclosed closet under the stairs.

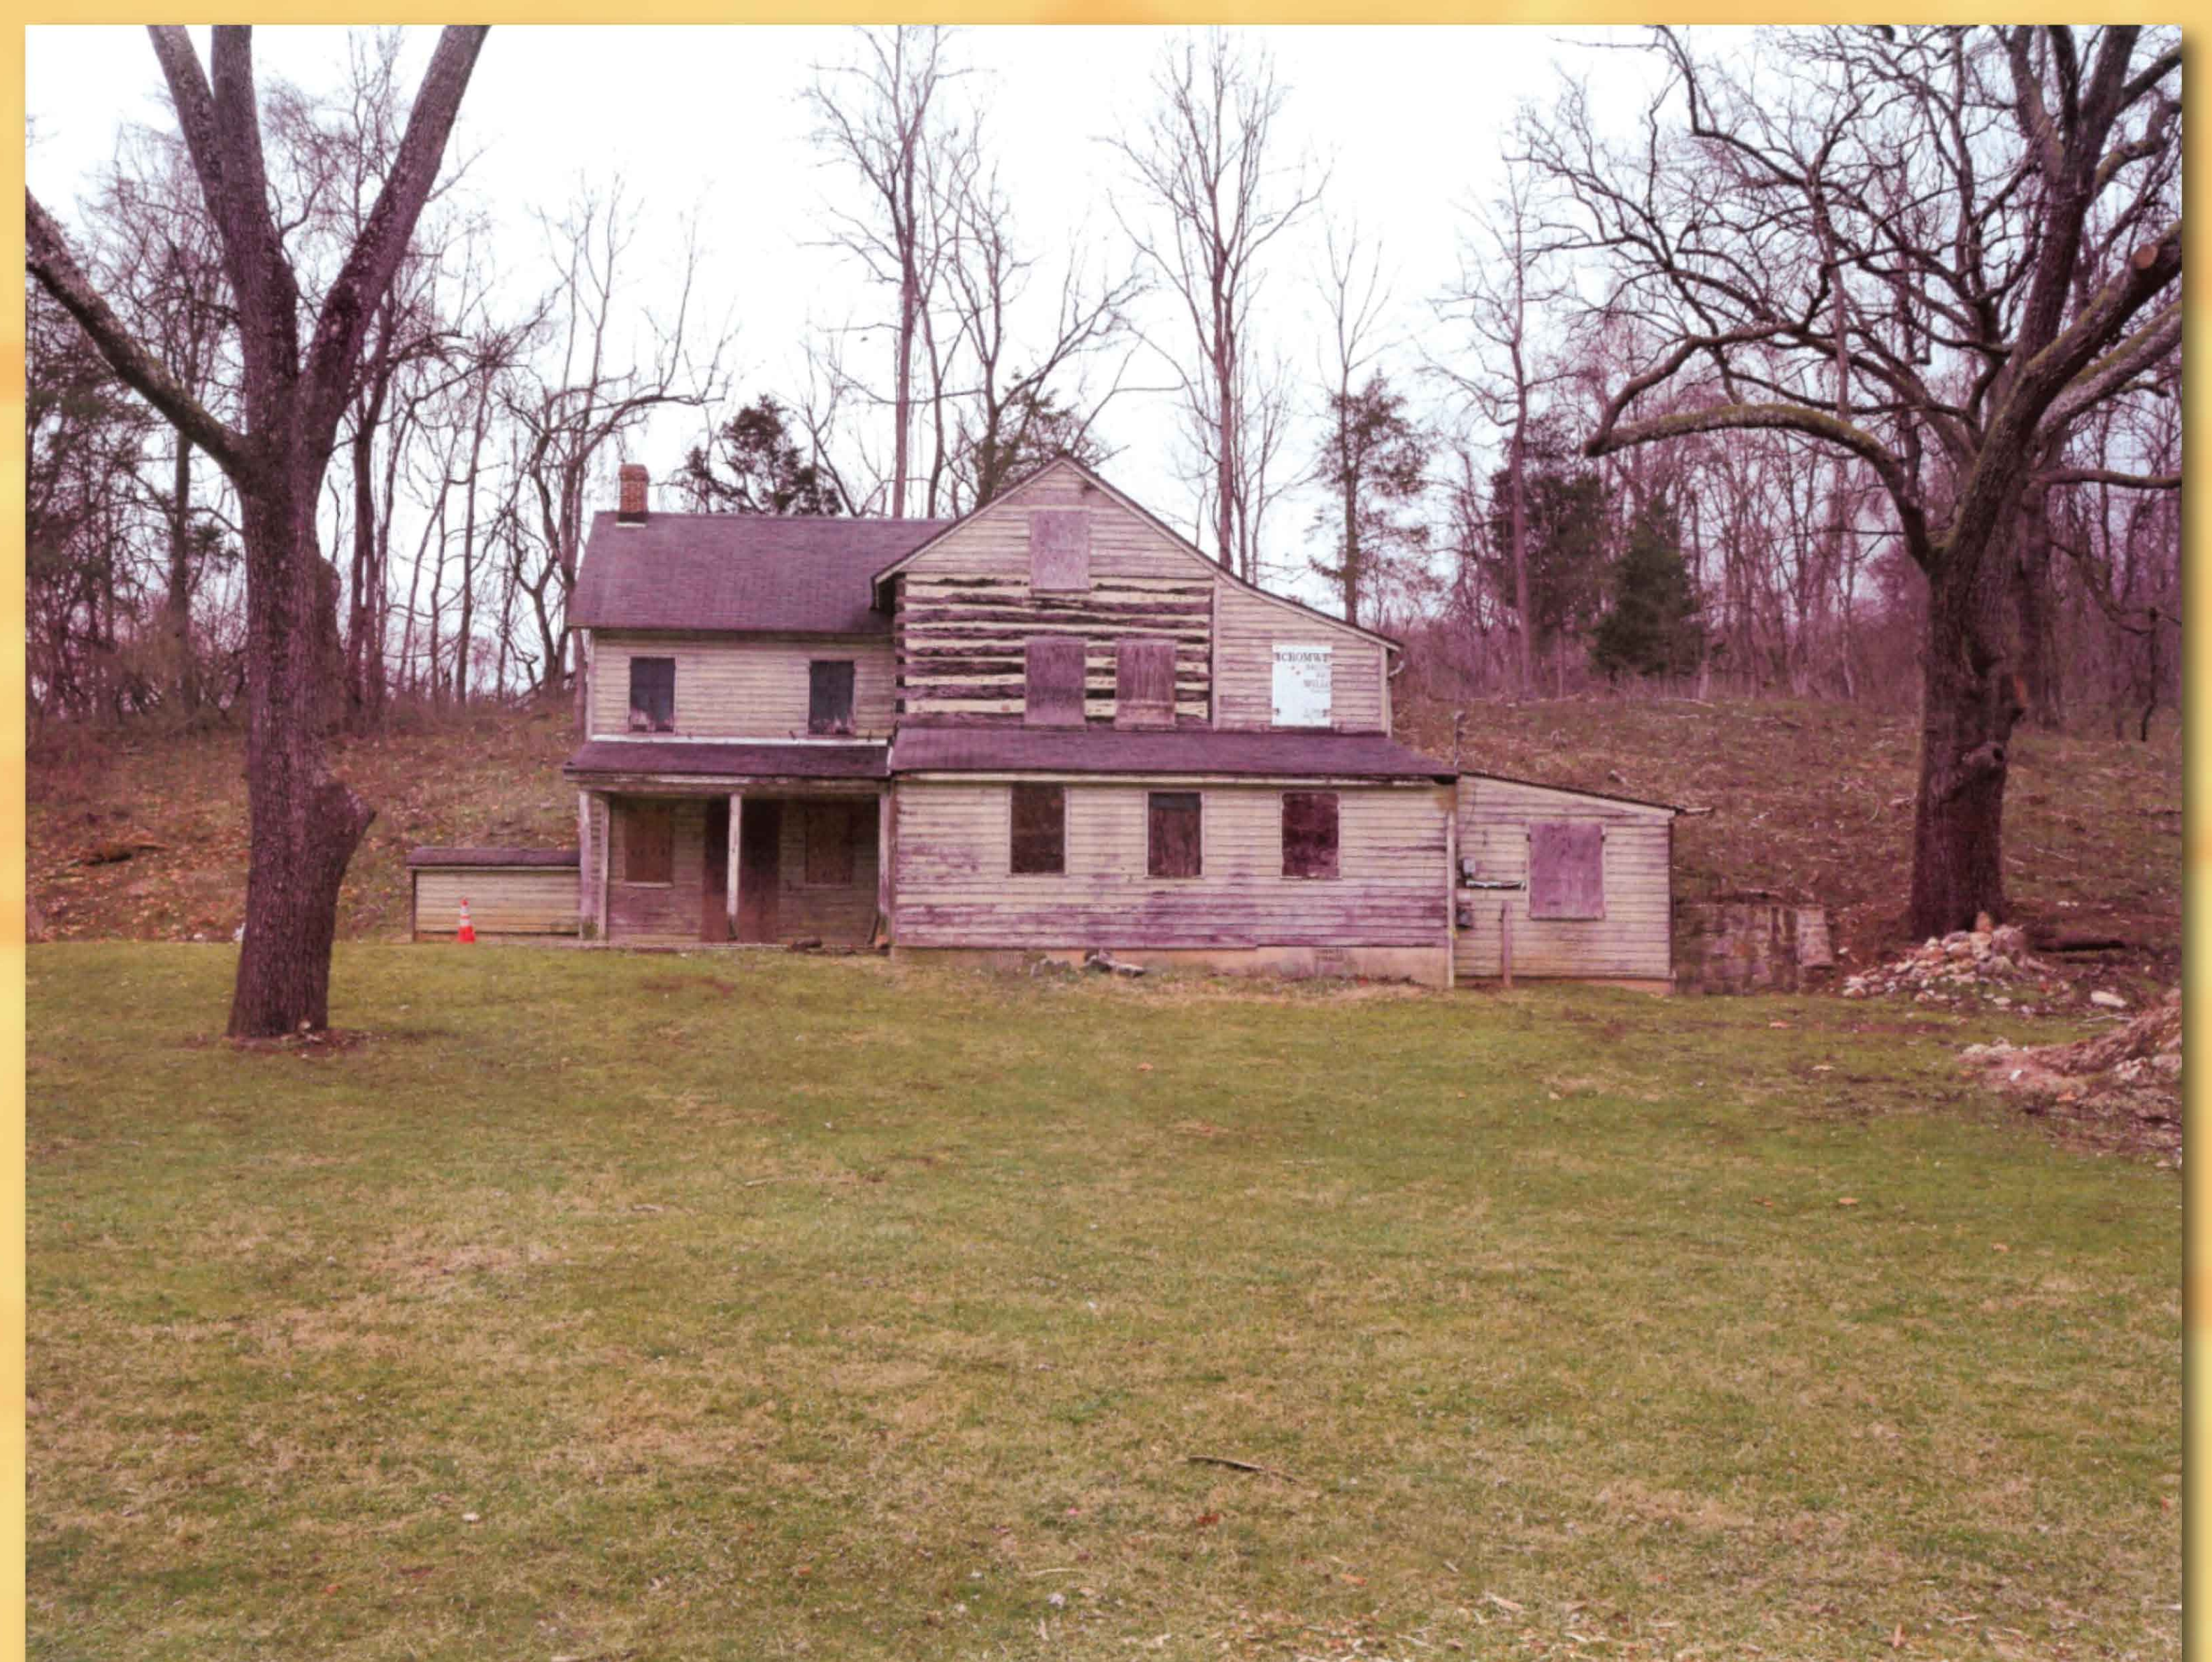
On the left at the top of the stairs, there is a doorway into the second floor of the log house. Ahead and to the right is a large room, probably used as another bedroom. Above this room is an unfinished, blind attic showing original cedar shake shingles of the log house roofing.
